Example of a Successful Application

Repair of Heat Exchanger Casing

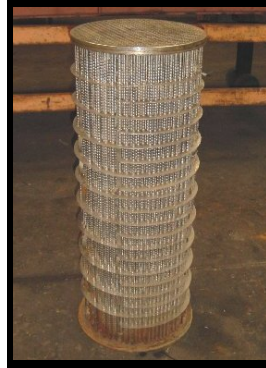
This is the nest from the Heat Exchanger Unit

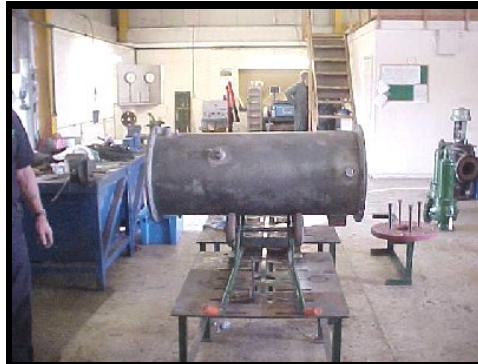
This is the CASE for the Heat Exchanger Unit

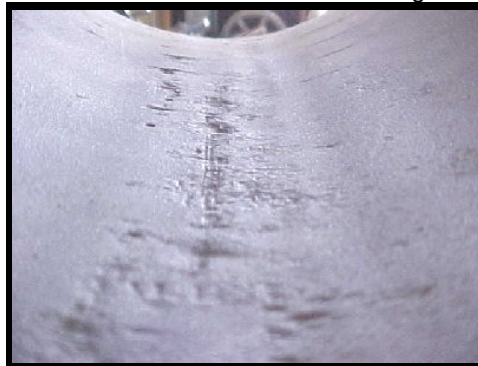
This shows all the DAMAGE caused by the application to the inside of the Heat Exchanger Unit

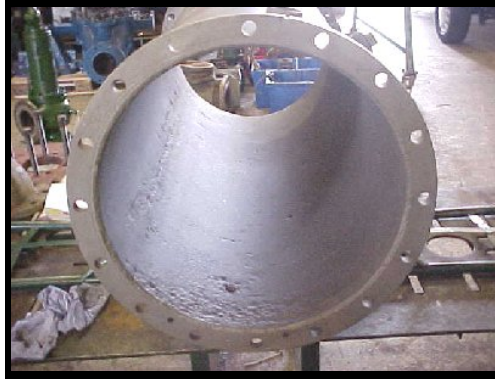
Here, you can see that the damage is NOT just in one area but ALL over the inside of the Heat Exchanger Case

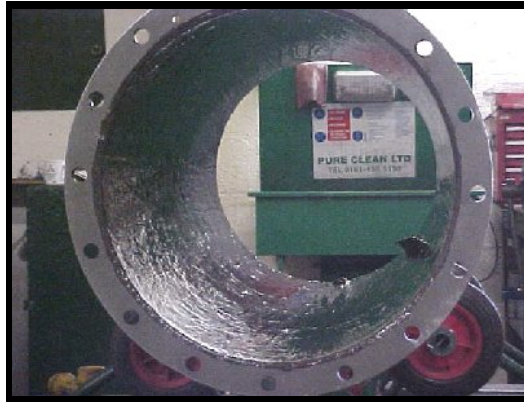
The unit is now ready to go back to site and on-line!!
