Example of a Successful Application

Power Station Application

A profitable repair and coating contract was won by Dutch Thistlebond Distributor in the face of stiff competition. The Dutch distributor for Holland has just completed a extensive repair and coating application in a Major Coal Fired Power Station located in Holland.

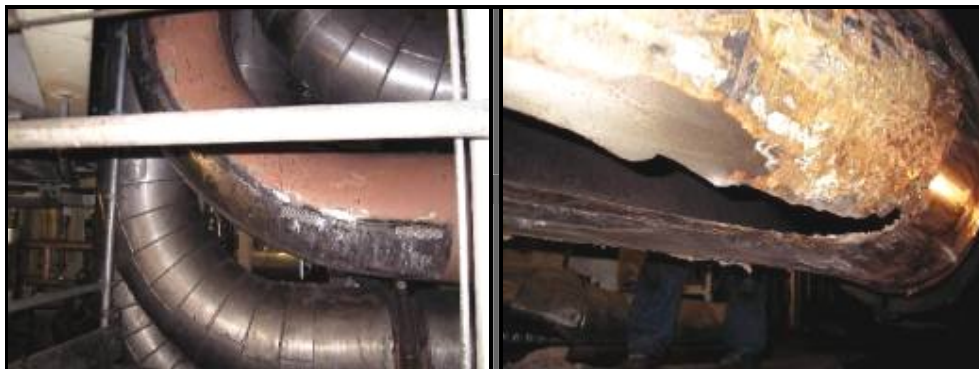
The coal dust (fuel) is very abrasive to all areas that it comes into contact with. This is especially noticeable on the elbows of the fuel feed pipes. The abrasion is made worse by the velocity of the material going through the pipes.

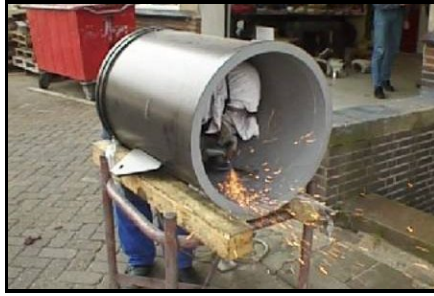
Pipes were taken out in sections that were 2 – 4 metres in length. Pipes were grit blasted and abraded to a SA2-1/2 specification + a 75 micron surface profile (rough not smooth surface finish). The pipes were then quickly assessed for damage.

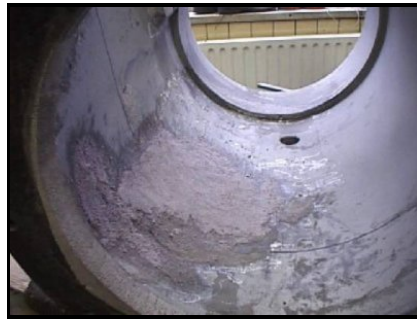
In many sections of pipe the most extreme damage was over a 40% area inside. This area was firstly treated by THISTLEBOND degreaser to make sure that no residues were left in place to affect the bonding of the polymer material. Thistlebond TR200 Ceramic Carbide Wearing Compound (paste type material) was then applied using both spatula and trowel as in some areas it was required to be in excess of 8mm thick.

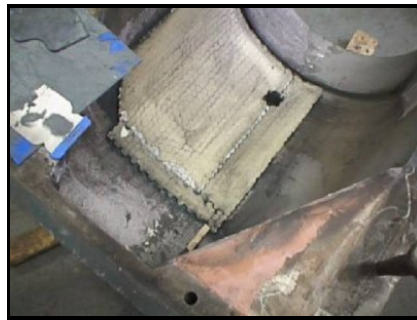
In the extremely badly worn areas the use of Ceramic Tiles – held in place by Thistlebond TR200 were applied.

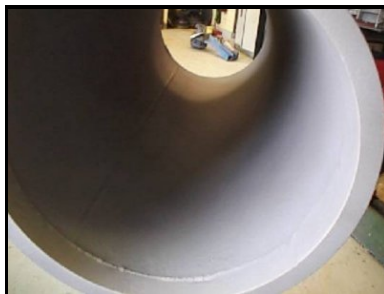
After waiting for the recommended period prior to further application – two coats of Thistlebond TR205 Abrasion Resistant Ceramic Carbide Fluid were applied to the inside surface. After appropriate full curing the pipe were stored prior to re-application in line.

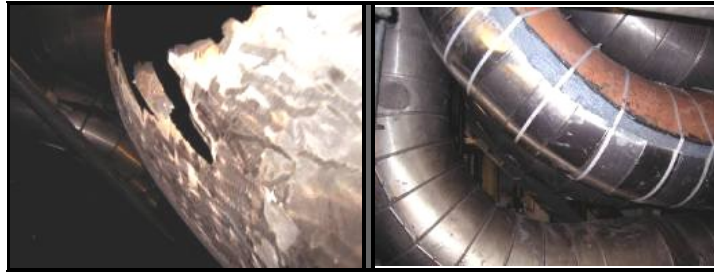
On the majority of the pipe ELBOWS, extreme wear had taken place (in some instance had worn right through pipe?). On all these pipes, THISTLEBOND TR240 Heavy Duty Ceramic Carbide was used in conjunction with ceramic tiles.

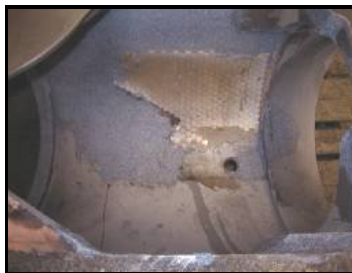
The tiles were kept in place by “sandwiching” them between two layers of the Thistlebond TR240 Heavy Duty Ceramic Carbide. Everything was kept in place by the use of steel ties until fully cured. As the Power Station was operational at the time of the applications, temperature was most suitable for the accurate curing of the Thistlebond Polymers.

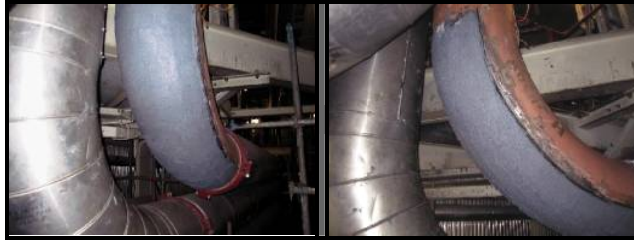
To this end an ingenious method of evaluation has been designed by ROODHART. The wall thickness of the pipe work when new is 22mm. The abrasion caused by the coal dust can and does eliminate ALL the wall thickness. It was decided that the bench mark for further repair and coating applications would be at 5mm. Roodhart have inserted a very thin copper wire on the OD of the steel pipe. It is held in place by Thistlebond Fluid Ceramic. Then the Thistlebond heavy-duty ceramic (TR240) is placed on top. Then the ceramic tiles are put in situ with a further coating of the heavy-duty ceramic.

As there is the possibility of an electrical current between the steel pipe and coal (should the wall thickness become extremely small) then a current can be measured from the copper wire. This enables not only preventative maintenance to be carried out but also is a good indicator as to the performance of the Thistlebond Ceramic Products.
