Example of a Successful Application Industrial Roller Systems

The Unique Polymer Systems Distributor in Poland has recently carried out a coating application on a roller. The problem was SLIPPAGE.

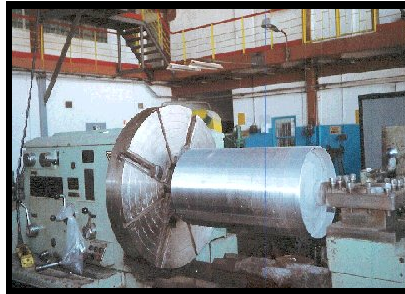
This picture shows the roller after having surface preparation prior to the coating application. Angle Grinding took place whilst in situ.

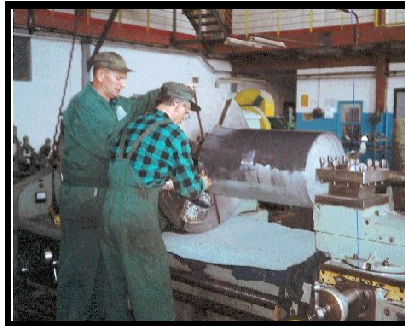
THISTLEBOND TR 205 Fluid Ceramic was applied along with SiCa particles (#24) included in the WET application.
