Example of a Successful Application
Thistlebond saves Oil Company £500,000!

HEADLINE!
**UK Thistlebond Distributor Saves International Oil
Company
over £500,000 by using Thistlebond Polymers!!**

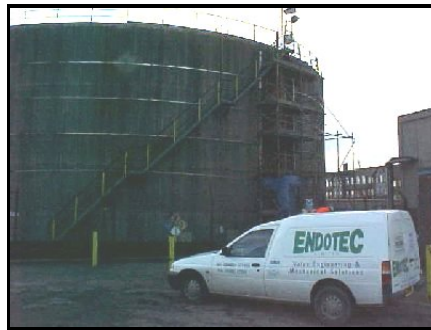
A leak developed in one of the tanks, but it could not be seen where the leak was due to the outside lagging of the tank.

To try to find the leaking area the lagging was taken off and about 3/4 way up the side of the tank a hole was discovered roughly 6mm in diameter, with further perforations.

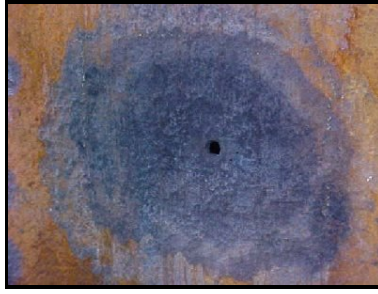
After the damaged area had been identified, 15000 gallons of crude oil was removed by tanker to allow the level of the crude oil to be brought to 2 feet below the leaking holes.

The area around the hole was then prepared - using hand held grinders - to roughen the surface to a minimum sa2-1/2 (75 micron) surface finish.

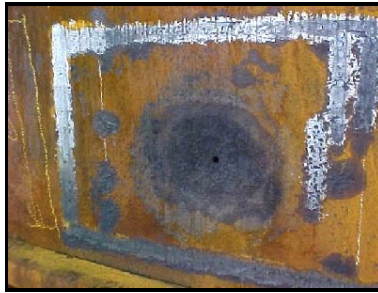
The hole was then initially repaired on the diameter (cross section around 6 - 7 mm) with [Thistlebond TRK19060](#). After mixing the [TRK19060](#) and inserting into the OD of the hole, the repair was then built up using same product.

After initial curing a further layer of [TRK19060](#) was put on top of the repair and [Thistlebond TBRT Reinforcement Tape](#) was pressed into the still soft Metal Repair to add a degree of rigidity to the repair.

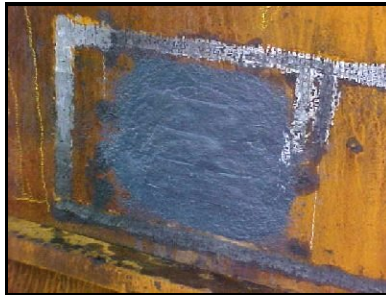
After which the tank was re-filled and then a steel plate measuring 1.5m X 1m was welded over the TRK19060 repair.

It is important to point out that the TRK19060 HELD UP AGAINST the pressure of the oil contained in the tank at this stage to allow the welding to take place in a DRY atmosphere.
