EXAMPLE OF A SUCCESSFUL ENGINEERING APPLICATION

Cooling fins on transformer suffering from extreme corrosion

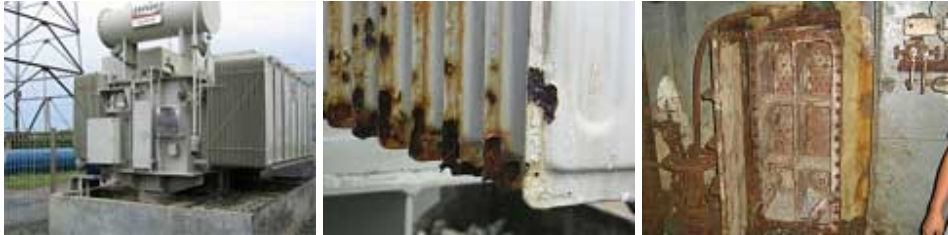
Cooling fins on transformer suffering from extreme corrosion. Transformer is located by coastal region so there is also an element of SALT WATER corrosion.
