Cargo Hold Repair and Protective Coating

ThistleBond Hycote 152 SFE & 152 SFE AS.

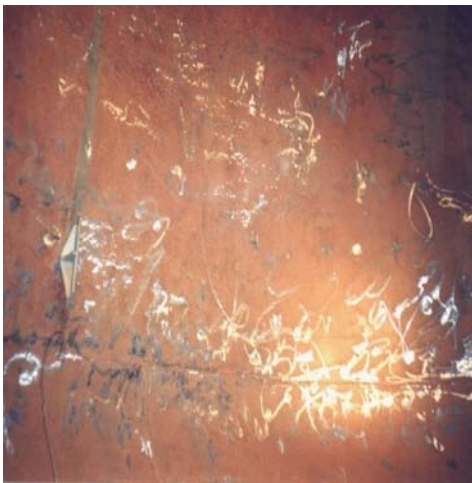
The Cargo Hold to the left had been used to carry powders over a period of time. The solids in the product had worn through the original protective coating and had started to attack the bare metal underneath. ThistleBond was approached to provide a coating system that would repair and protect the steel sides of the hold.

The Cargo hold was Hydroblasted and then cleaned using ThistleBond Universal Cleaners. The product chosen to protect the Cargo Hold was ThistleBond Hycote 152 SFE and SFE AS. All seams and sharp edges were coated with coat of Hycote 152 SFE (Brush Applied), then one coat of Hycote 152 SFE AS (Airless Spray) was applied over the top. Due to the high film thickness of the coating this was a one coat application, ThistleBond gave a 5 year warranty on the work..
