## Case History – ThistleBond Hycote 152 SFE Marine Deck Coatings

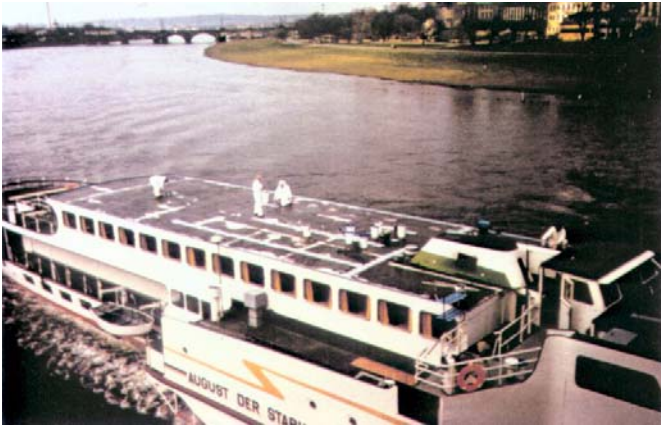
The German Ferry shown to the left had bad corrosion on the roof.

ThistleBond was asked to provide a solution for this particular problem and was given the contract to perform all the application work.

The Deck was blast cleaned to SA 2.5 50 micron profile and then degreased using ThistleBond Universal Cleaner
