Case History – ThistleBond Fairing Compound and Abrasion Resistant Ceramic Carbide Fluid Engineering Repair and Maintenance

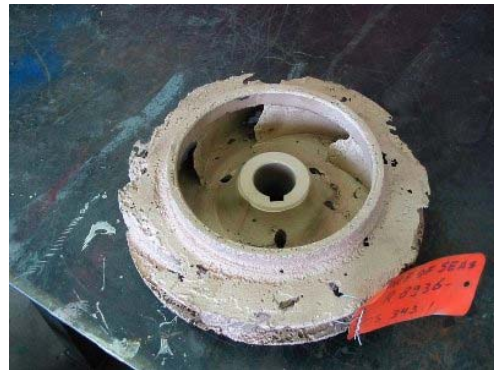
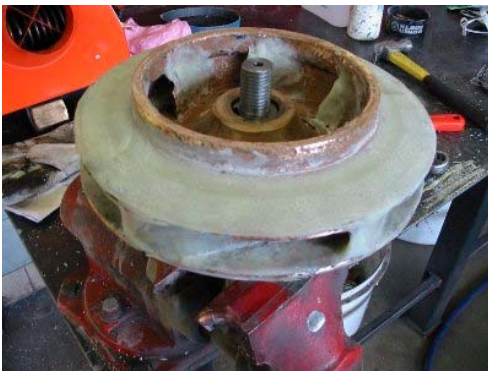
The Pump had been used on a Cargo tanker and been in operation for over 15 years. The performance and efficiency of the pump had become so bad that it was decided to take the equipment out of service and repair any damage. Unfortunately the spare part was no longer being manufactured by the OEM and so the shipping company looked to ThistleBond to repair the damaged components.

Wire was welded to the outer edges of the impeller, so as to obtain the original shape and dimensions. ThistleBond Standard Resin and Hardener was then mixed with Fairing Compound, a special blend of glass strands and flakes. The mixed product was applied by thin layers to the damaged component and eventually the impeller was brought back to its original shape.
