Reinforcing a Chemical Tank Hold
Location: Canada

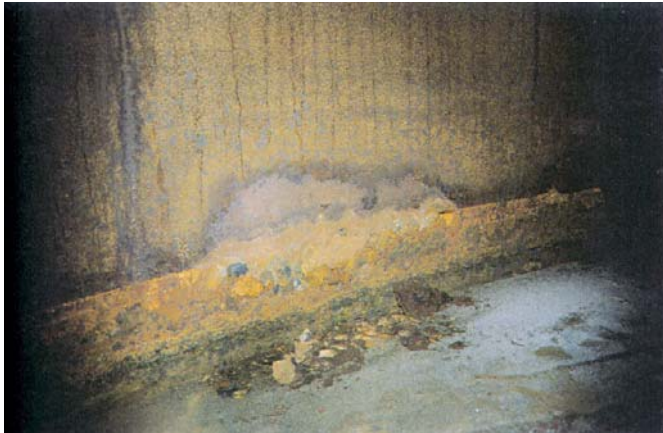
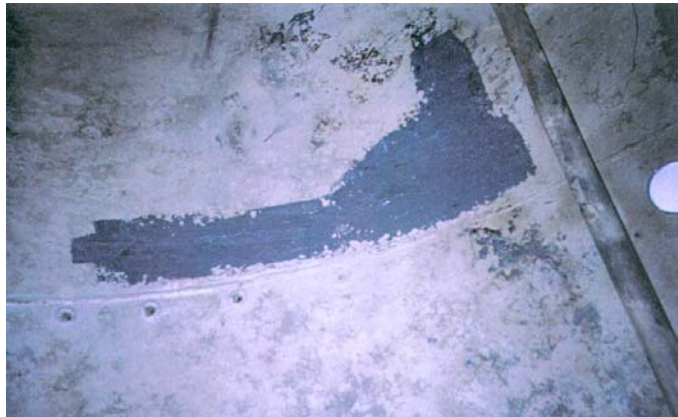
The vessel and been transporting Hydrocarbons for extended period of time. The vessel owners had found sporadic corrosion on the internal surfaces of the Chemical tanks. In some areas, the entire protective coatings had been eaten away and had begun to attack the surfaces of the steel. The engineers asked ThistleBond to propose a practical and long lasting repair.

The effected areas were grinded down to bare metal. ThistleBond Universal Cleaner was then used to clean the surface of any dirt, grease or other contaminants. Super Metal Rebuilding System was then mixed and applied to the prepared surface, once all holes and pitting had been filled, the Super Metal Rebuilding system was then applied to some reinforcement tape and this was laid over the cracks in the steel surface. The system was then allowed to set, before a coat of ThistleBond Hycote 175 Chemical Protection was applied
