Case History – ThistleBond Hycote 152 LV Marine Deck Coatings

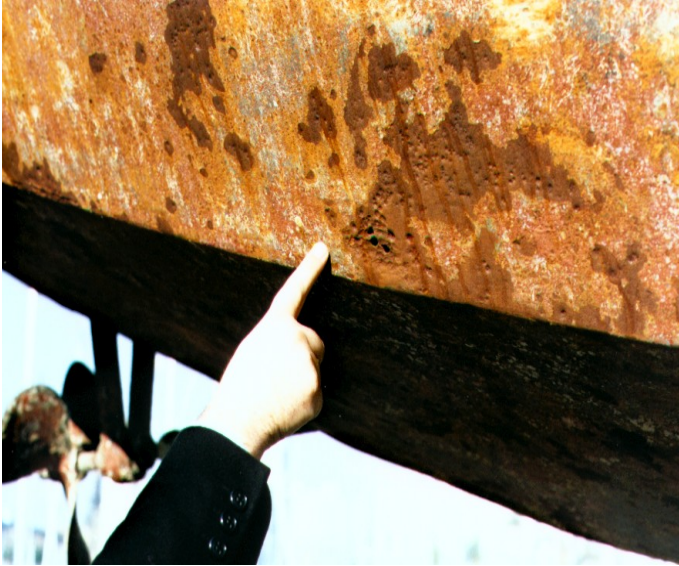
The bottom of the steel hull had not been cleaned or anti fouled for over 6 years.

After taking the boat out of the water it was badly corroded and the rust had worked itself as far as 14mm into the steel bottom.

The steel hull was blast cleaned and degreased using ThistleBond Universal Cleaner.

All pitting and scarring was filled using ThistleBond TR105 Super Metal. This solvent free epoxy paste is ideal for heavy duty applications and can be easily machined down to a smooth finish
