Case History – Water Pump Repair and Refurbishment
ThistleBond Ceramic Carbide Wearing Compound and Abrasion
Resistant Ceramic Carbide Fluid.

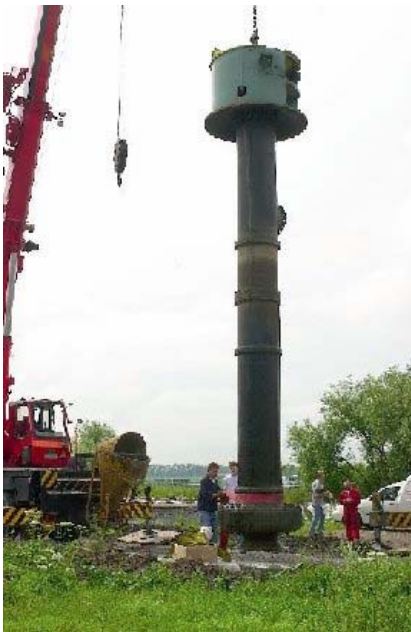
The ThistleBond Dutch Distributor was awarded the contract to repair and Refurbish one of the largest water pumps in the Netherlands. The entire piece of equipment was lifted from its existing station and transported to Roodhart's Head office in Rotterdam. The pump was dismantled to assess the damaged to the wet end of the pump and to the drive shaft and components.

The wet end of the pump had been severely eroded over a period of years, the Impeller and Volute were blast cleaned to SA 2.5 Swedish Std. Then all surfaces were cleaned using ThistleBond Universal Cleaners. A check on the severely effected areas showed heavy pitting and scarring on large areas of the Volute.

The pitting and scarring was filled using ThistleBond Ceramic Carbide Wearing Compound. Once this product had reached its minimum overcoating time, two coats of ThistleBond Super Low Friction Efficiency coating was applied to all of the surface areas of the Volute and Impeller.
