## Example of a Successful Application Internal Pipe Protection - Sales Opportunities

A recent successful application as carried out by a European based distributor for Thistlebond products shows exactly what can be achieved.

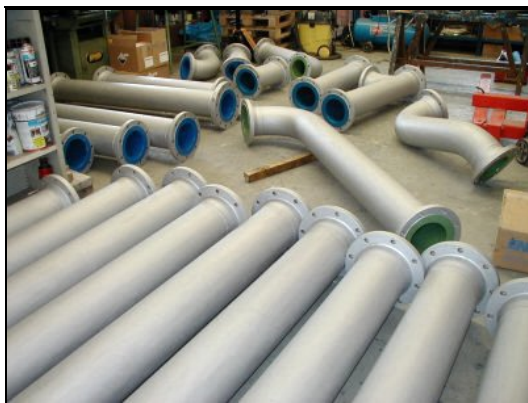
The pipes are 2 meters in length and have a 200mm internal bore.

All pipe were first "grit blasted" to 75micron surface roughness (sa2-1/2). Pipes were then solvent wiped and the **Thistlebond TR240** was then applied using techniques developed by the distributor.

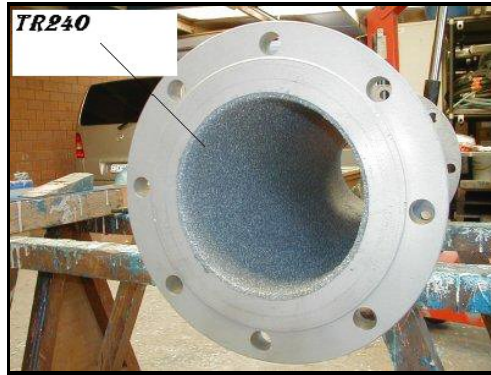
On average the coating was 5mm thick and Fluid Ceramic was then applied to the overall surface finish and onto the pipe joint faces.

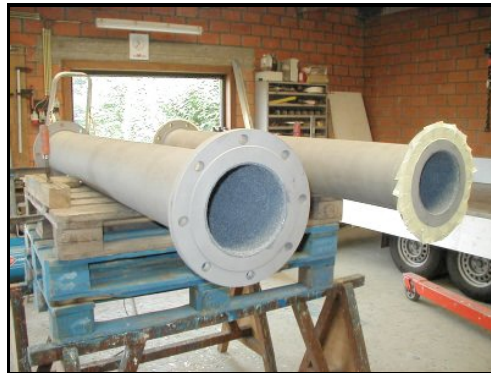
A total of 40 X 5 Kilos of TR240 was used on this application and the end user was extremely pleased with the results that will make major financial savings for the company. Further application work is now being negotiated by our distributor
