Example of a Successful Application

Steel Mill Cooling Water Pumps

STEEL MILL COOLING WATER PUMPS

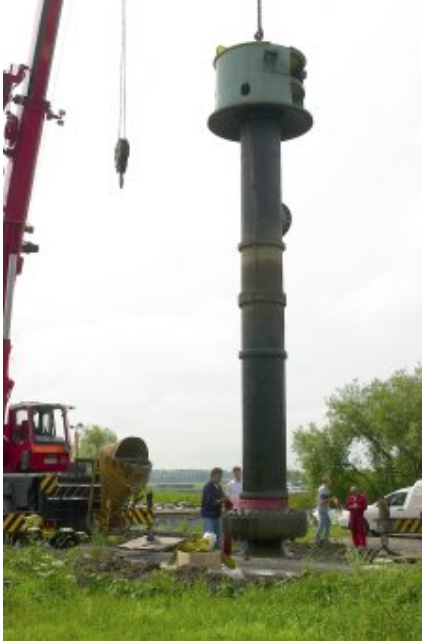
These pumps are some of the largest rotating pump units operating in the Netherlands.

Their capacity is 20,000 cubic meters/hr @ 750 rpm. Pump length is approximately 13 meters and the width @ volute is approximately 2 meters. Motor size is 2 mega-watts.

The purpose of these pumps is to remove water from a river which is then used as a circulating coolant in an adjoining Steel Mill

The pumps are pulling in sand and silt from the river which is extreme abrasive to the WET END of the rotating units - causing severe damage to volute and impeller.

A pump unit was removed from its location by crane and lorry. The unit was then taken to ROODHART engineering workshops, where it was dismantled into manageable parts.

The complete wet end of unit was then taken for grit blasting to a .75 micron surface finish.

The damaged volute was repaired by hot metal. Other damaged areas were re-profiled with THISTLEBOND TR240 - Heavy Duty / High Abrasion Resistant Ceramic / Carbide Repair System

The complete wetted part areas were then coated with THISTLEBOND TR 205 Abrasion Resistant Fluid Ceramic. The unit was then re-assembled and returned to the application site.

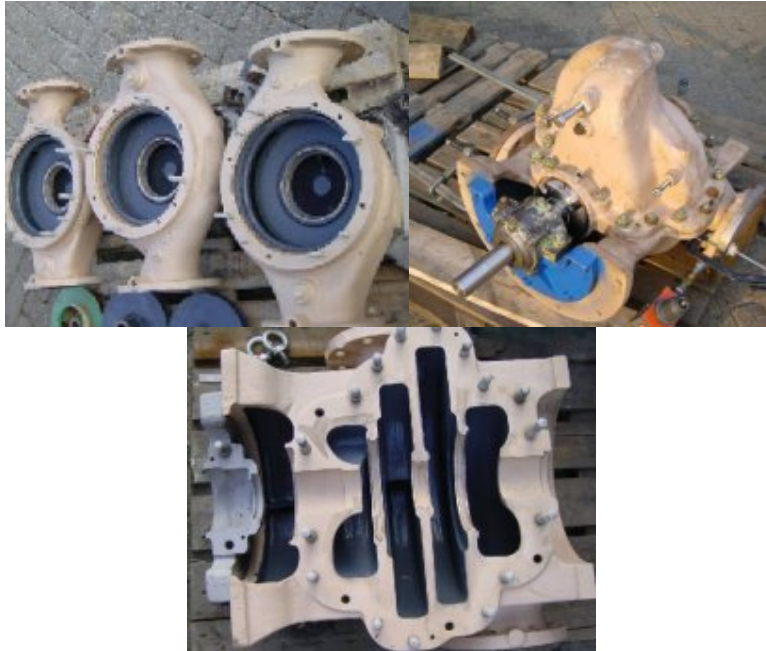
All of the following pumps were located ON BOARD SHIPS. They are for various applications ranging from FRESH water to SEA WATER applications.

In all cases the same PROBLEM existed. Erosion and Corrosion effects of WATER.

In all cases the same SOLUTION applies. The use of THISTLEBOND TR 200 to repair damage and to re-profile where required and TR 205 to provide a protection surface to guard against further Erosion and Corrosion!
