## Example of a Successful Application

### Major Floor Protection Upgrade

A Major Water Reclamation Plant (Sewage) in Europe has recently awarded a contract to the Unique Polymer Thistlebond Distributor in the area to completely refurbish their extensive floor area.

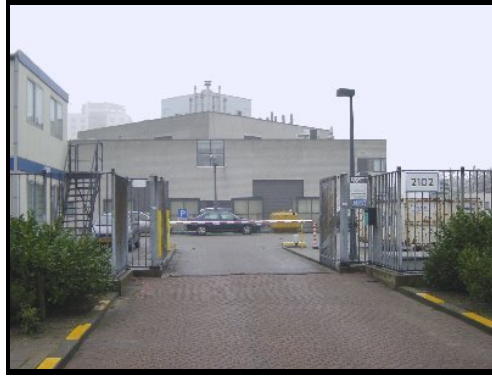
This SEWAGE facility is entirely UNDERGROUND and is one of the largest facilities in the WORLD. The facility is located on many different underground levels. This fact was also instrumental when the asset managers were searching for a reputable and well represented FLOOR COATING SYSTEM.

The area in question is over 6,000 square metres.

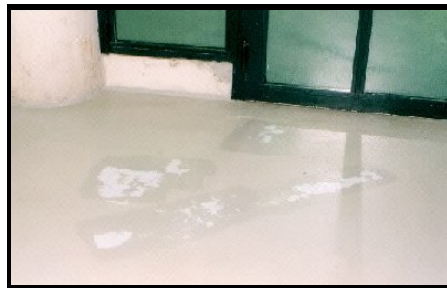
In the course of their visits the delegates have to walk through many many interlocking corridors, As this facility is TOTALLY underground, lighting and visual appearance are of paramount importance to the operators.

In many of the plant room areas where the circulating pumps are located, leakage from gland areas has caused unsightly dis-colorization to the existing polymer floor coating. There is also evidence of poor chemical protection by the existing floor coating.

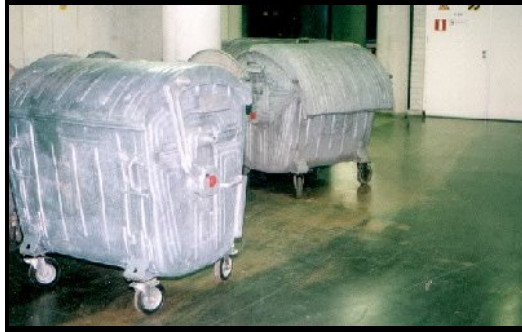
Another problem is that many steel wheeled trucks are constantly travelling along these corridors. The wheels have also been causing damage to the existing floor areas.

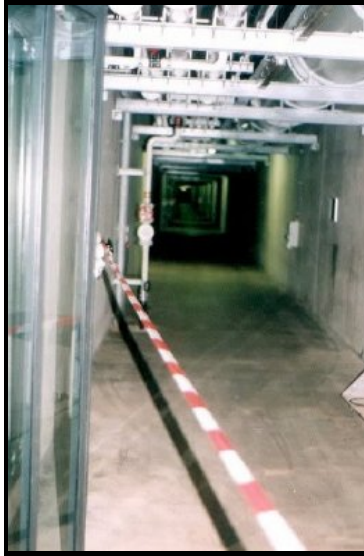
Firstly the floor was thoroughly cleaned and lightly abraded to provide the necessary key for initial first-coat adhesion. Any areas that were badly damaged were also made good at this stage using other Thistlebond products.

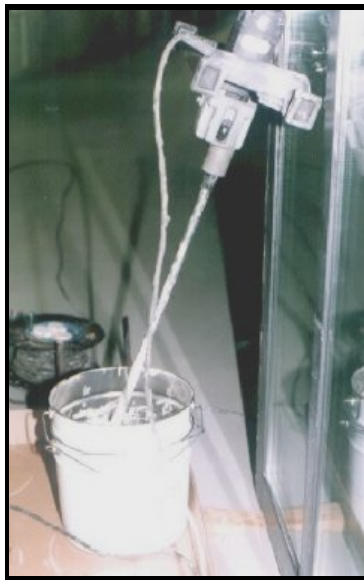
The BASE:ACTIVATOR were then thoroughly mixed using the correct mixing implements.

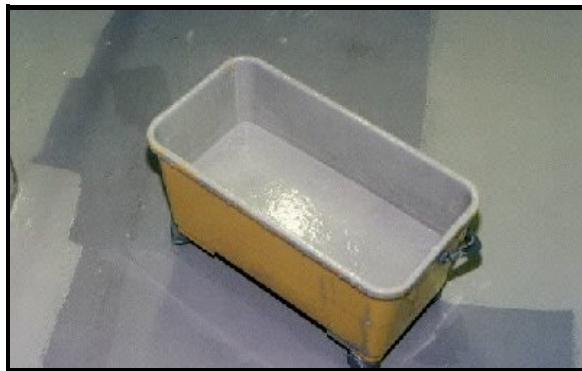
The product was then applied by ROLLER to the prepared surface.

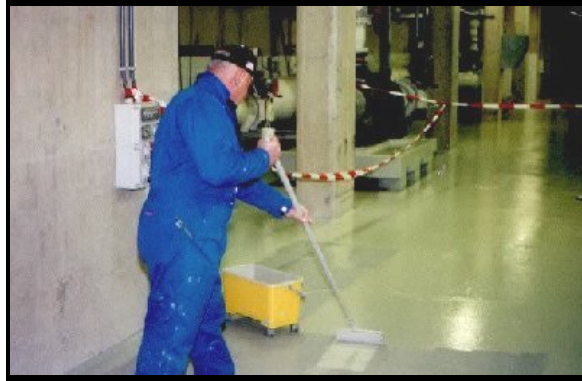
In the more difficult to reach areas, small rollers and brushes were used.

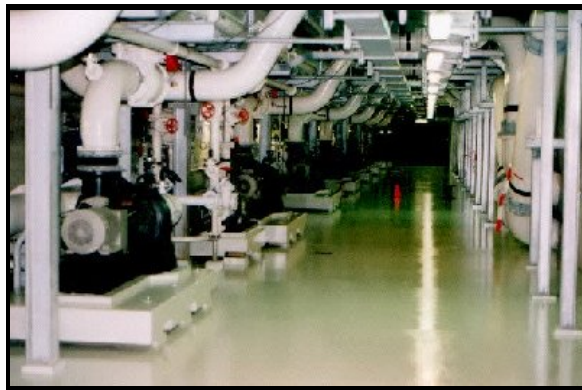
The final appearance of the coating system was "STUNNING" and the end user was so pleased with the end results that FURTHER coating applications are already being negotiated!!
