**Coating of a Chemical Tank Hold**  
**Location: Canada**

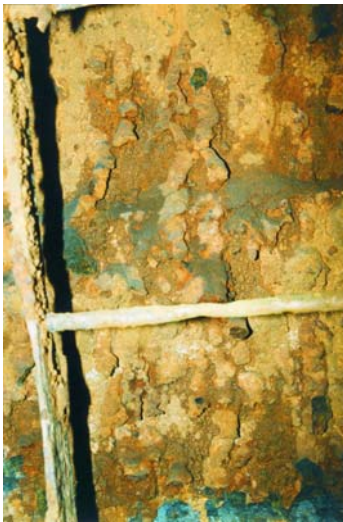
Due to the corrosive nature of the materials being carried by the vessel, the original coating had been eaten away and the steel surfaces had become badly affected. ThistleBond put forward a system that would ensure that the chemical tank would be protected for the next 10 years. Once the cracks and pitting had been filled in, the entire surface of the tanks was Hydroblasted. This was to give the product chosen ThistleBond Hycote 175 Chemical Protection a good surface to bond too.
